# *New York Row Houses: The Gothic Revival Style*

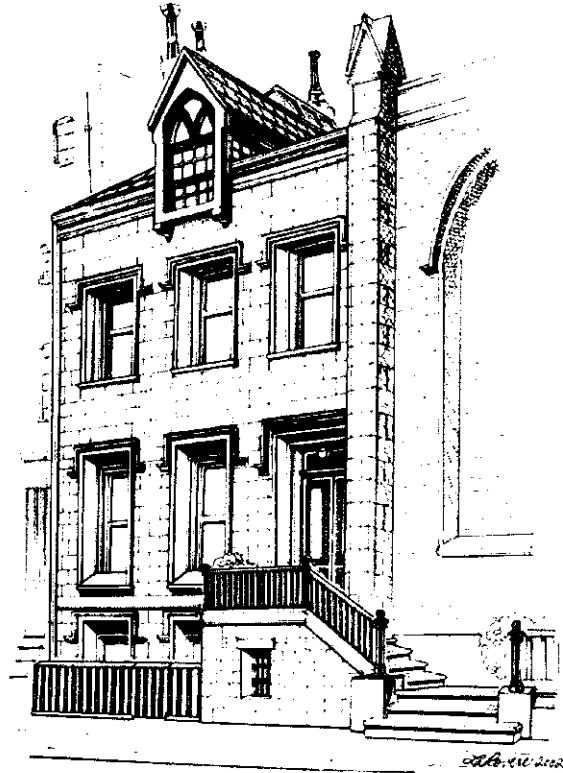
Front doorways, sills and window lintels took on several forms. Either rectangular or arched, they often protruded and possessed "hood molds". In lieu of a flat edge, these hood molds often employed Tudor arch molds at each end. Many of the more elaborate arched doorways featured an additional, horizontal "hood mold". The triangular space between the arched hood and the rectangular hood contained elaborate carvings of the Gothic motif, "trefoil," a three-sided leaf shape resembling a clover leaf shape. An extremely costly

process, carving elaborate Gothic ornament into stone was reserved for only the most expensive row houses.
